## FINAL REPORT

### CABOT OIL & GAS CORPORATION HEITSMAN #2V/#4H WELLSITE DIMOCK TOWNSHIP, PENNSYLVANIA

MAY 2010

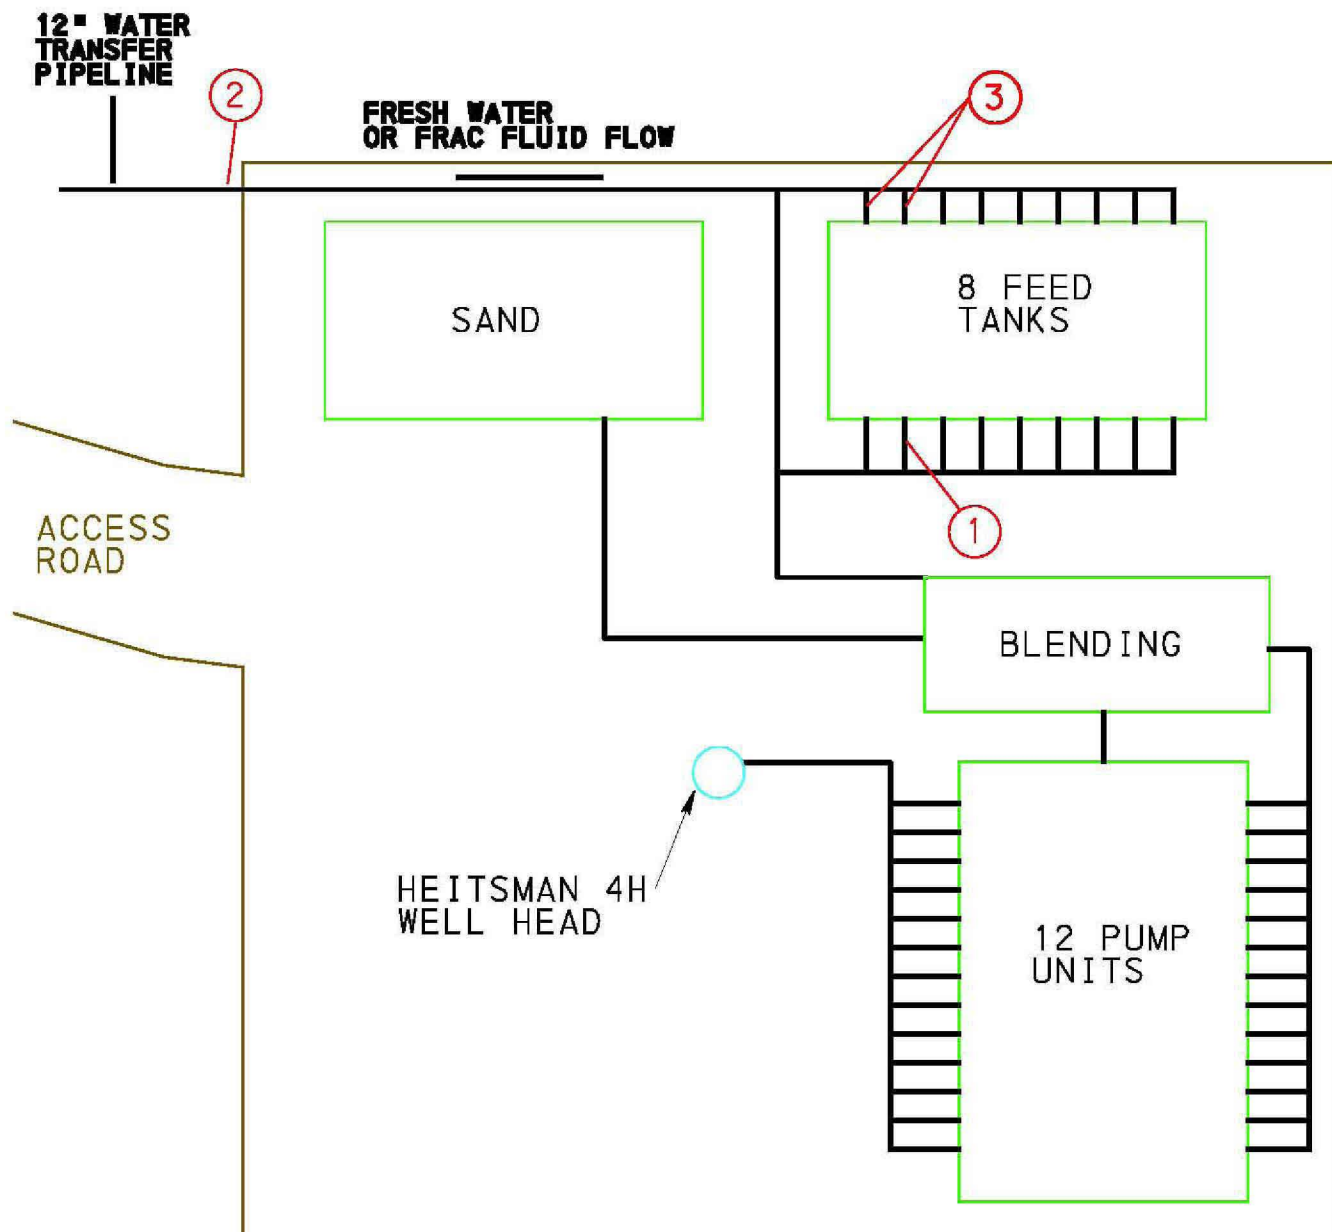
**FIGURE 4**

**HEITSMAN #4H WELL PAD  
SCHEMATIC**

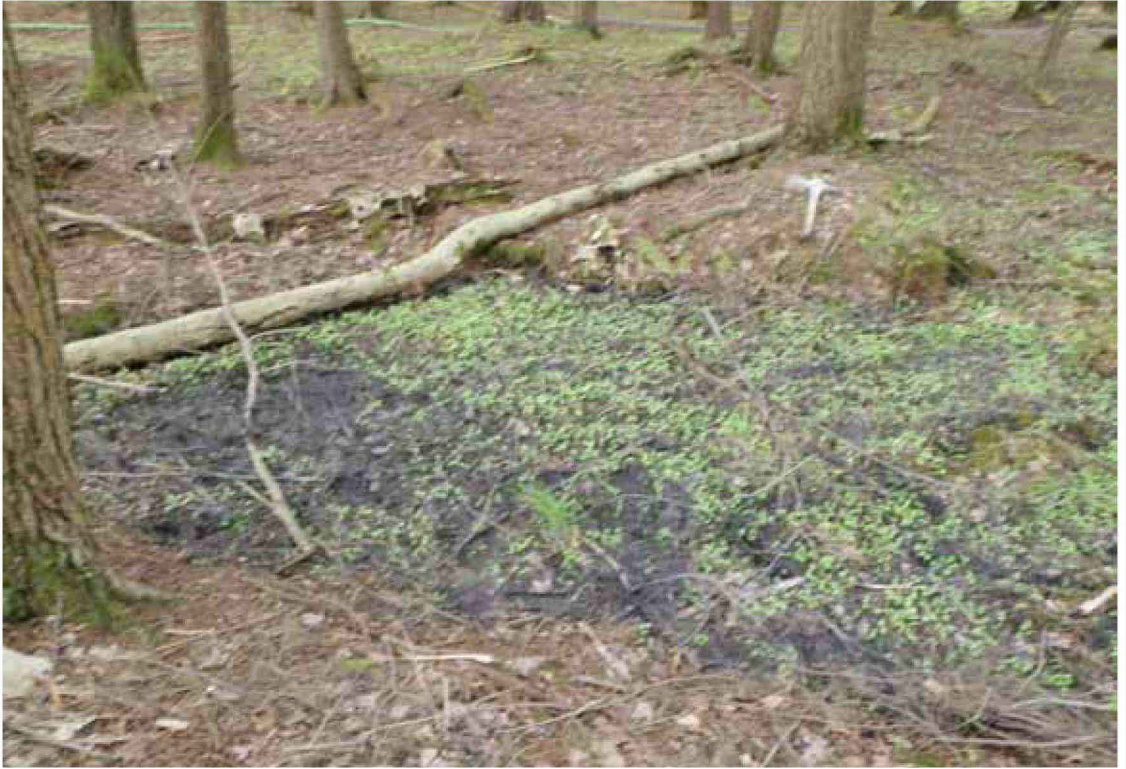
Cabot Oil & Gas Corporation		<b>Site Location:</b> Susquehanna County, Pennsylvania	<b>Project No.</b> 39938634.00008
<b>Photo No.</b> 3	<b>Date:</b> 5/08/09

<b>Direction Photo Taken:</b> South			
<b>Description:</b> Drilling mud impact confined to relatively narrow drainageway through the wetland. Note that impact is visually evident with the area of impact (black) within the non-impacted area (brown).

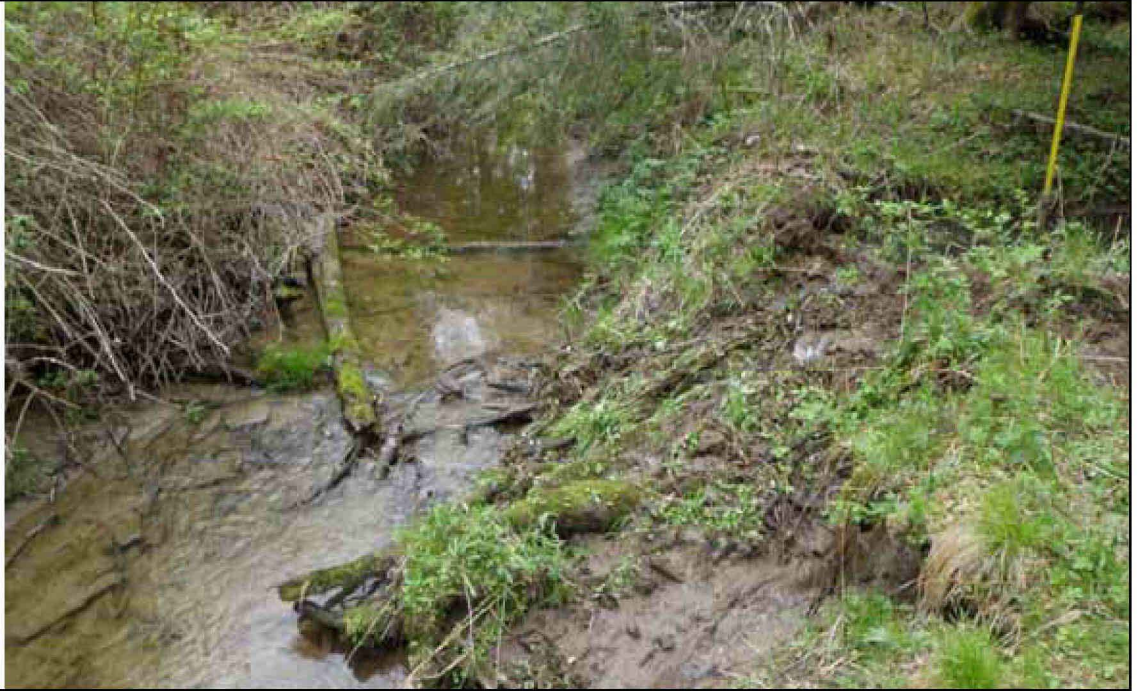
**Photo No.**  
**6**

Secondary dam adjacent to Stevens Creek. Note that no visual impacts to Stevens Creek are observed. Note that water behind the dam (to the right) is observed to be visually impacted (black) with drilling mud.

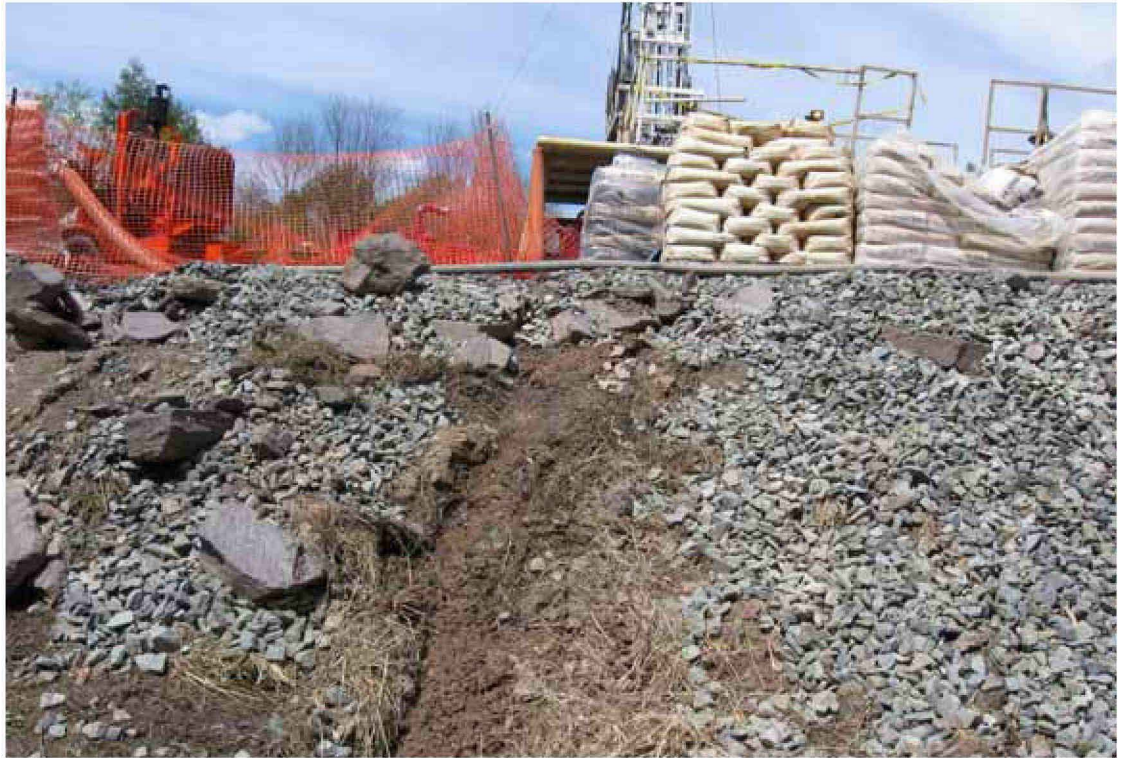
Seeps along western portion of the drill pad. Note outlet hose from the mud pump.

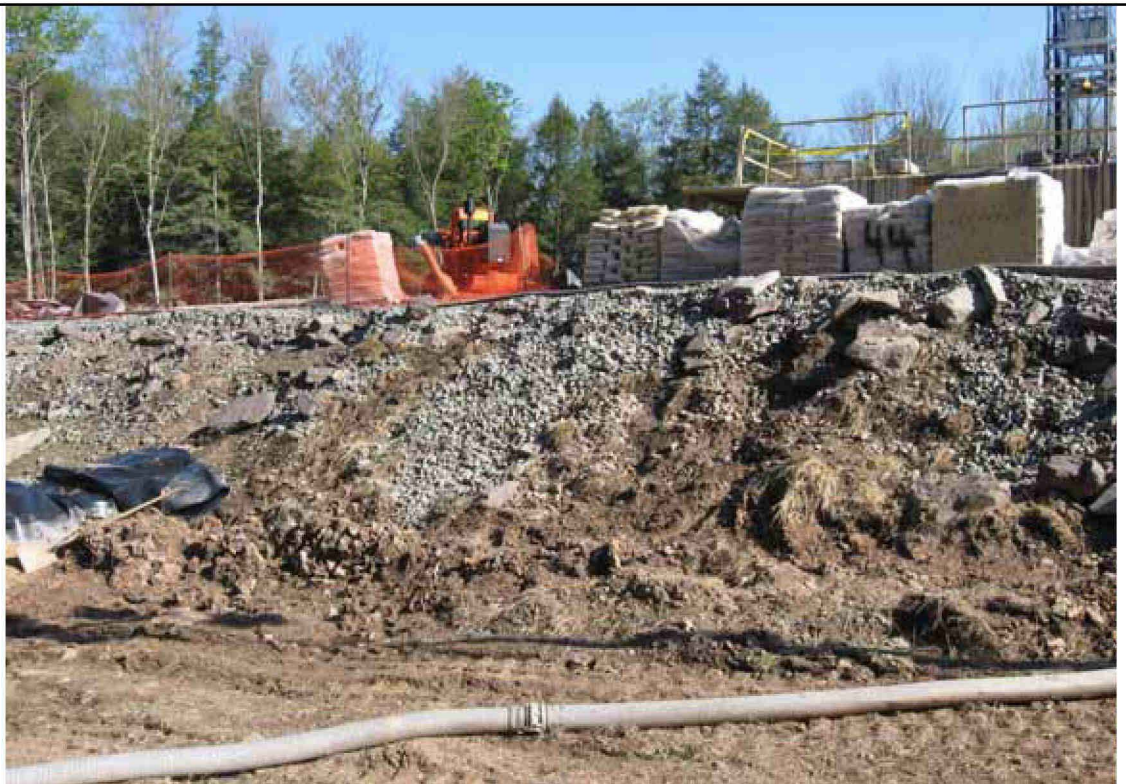
8

View of two of the three seeps observed in the vicinity of the mud mixer on the west side of the drill pad. Hose in foreground supplies potable water to the flushing crew remediating the wetland.

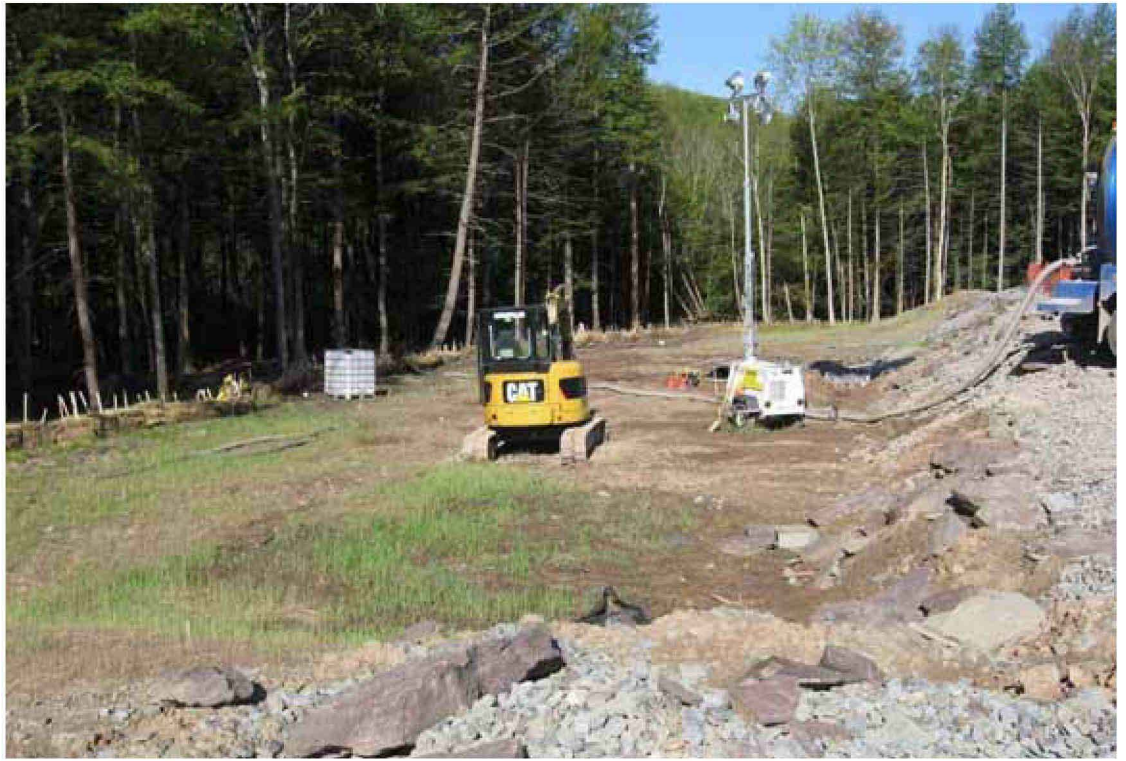
**Photo No.**  
**10**

Same area as above showing detail of equipment used during remedial efforts.

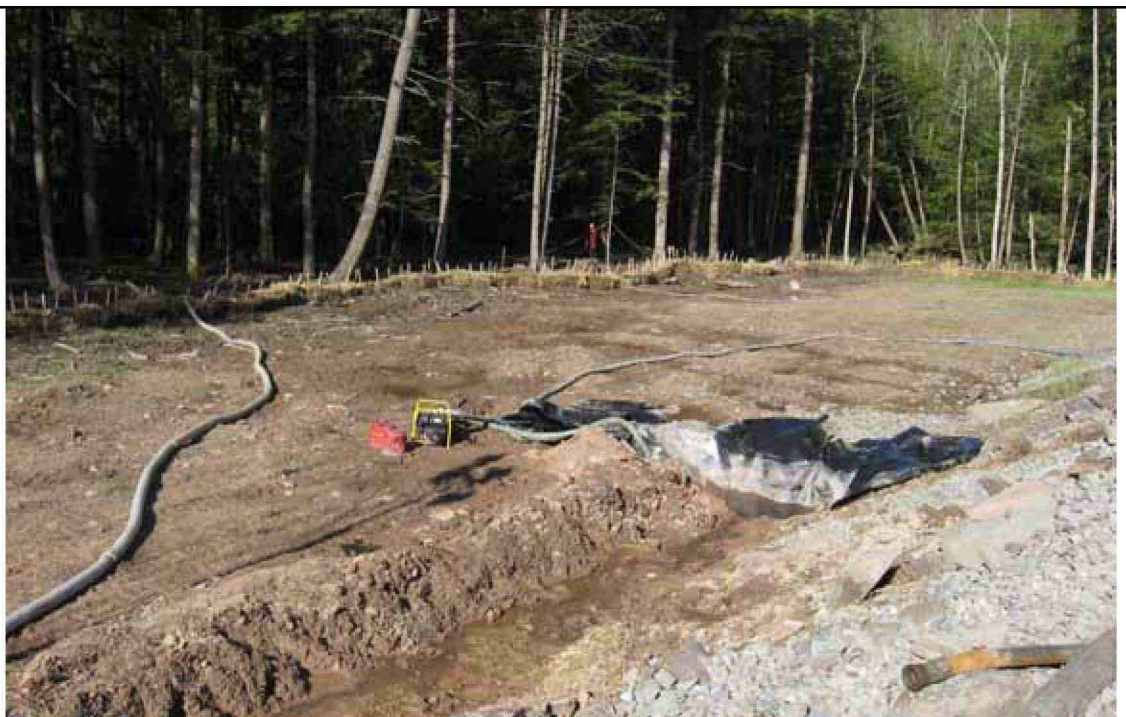
View of remediated area within the E&S controls, catch basin, pump being used to return flushed water to the disposal pit, and hose supplying potable water to the flushing crew. Note that all visual impacts (black) due to drilling mud spill have been remediated, and only residual soil (brown) is present.

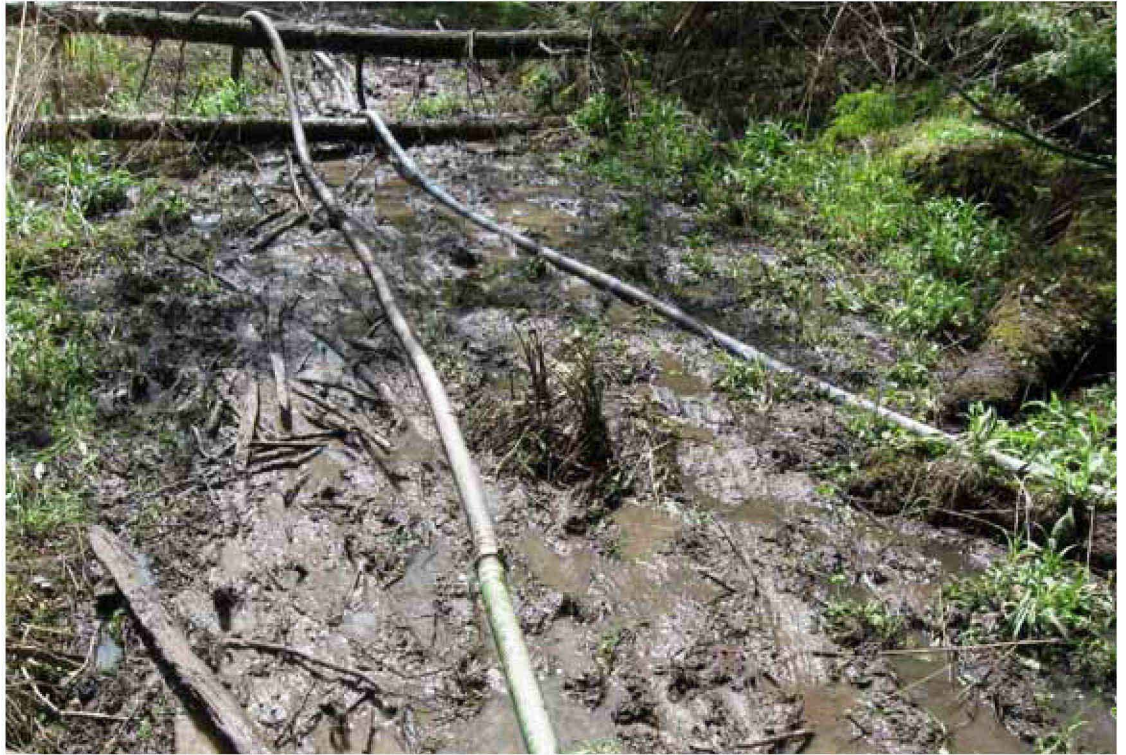
**Photo No.**  
**12**

Area remediated in the main portion of the wetland. Note that the wetland is brown and all visual impacts (black) have been flushed from the area as a result of remediation activities.

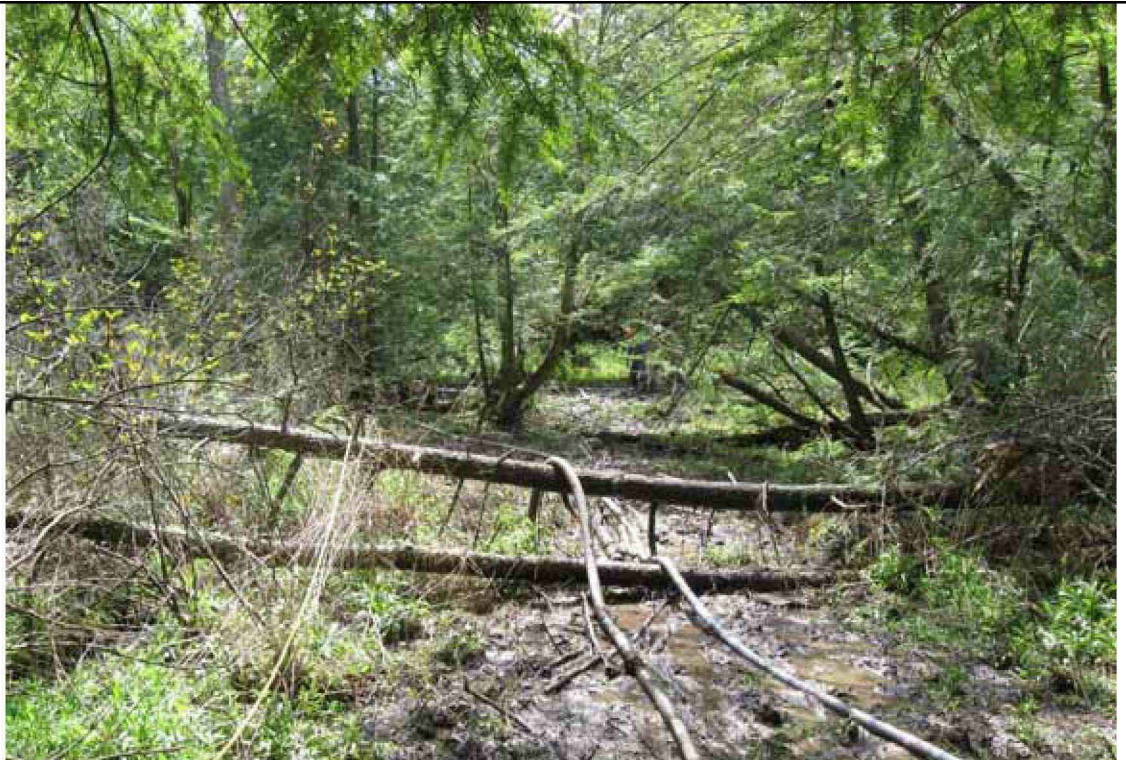
Area remediated in the main portion of the wetland. Note that the wetland is brown and all visual impacts (black) have been flushed from the area as a result of remediation activities. Note pump in the background used to pump water from the containment area to the disposal pit on the drillpad.

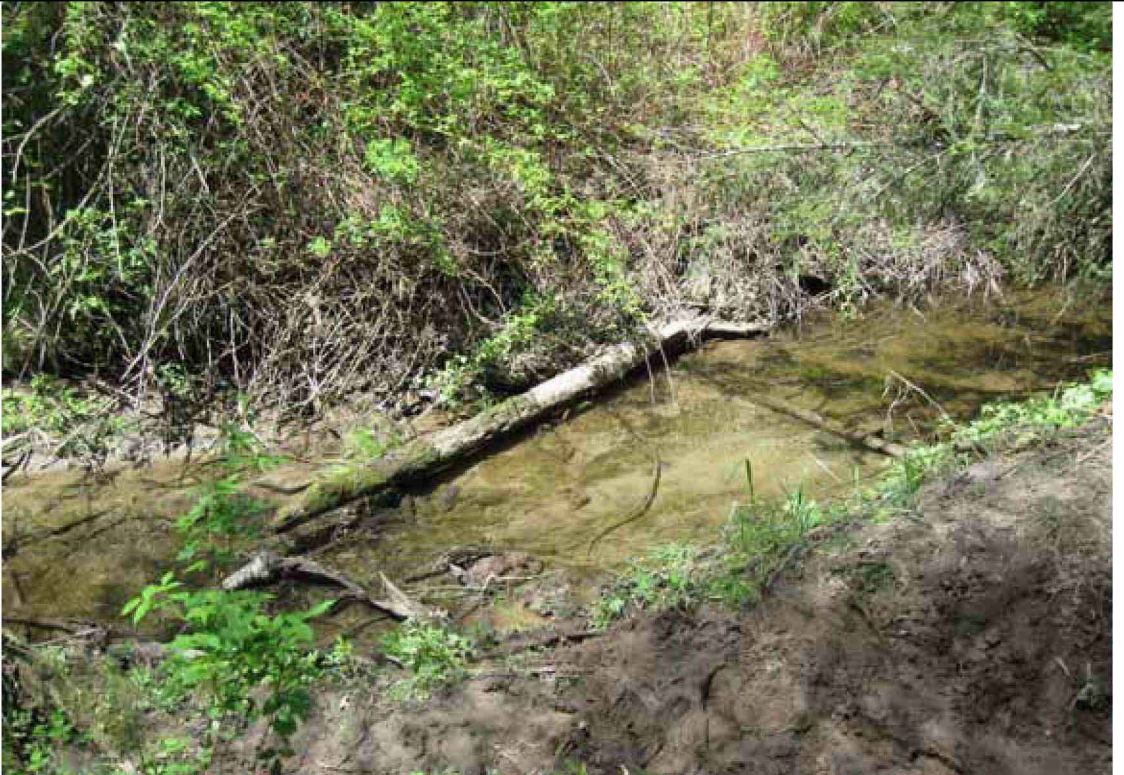
<b>Site Location:</b> Susquehanna County, Pennsylvania	<b>Project No.</b> 39938634.00008
<b>Photo No.</b> 13	<b>Date:</b> 5/11/09

<b>Direction Photo Taken:</b> Northwest			
<b>Description:</b> Stevens Creek upstream of the area where the impacted wetland would normally enter the creek. Note lack of visual impacts to the streambed.

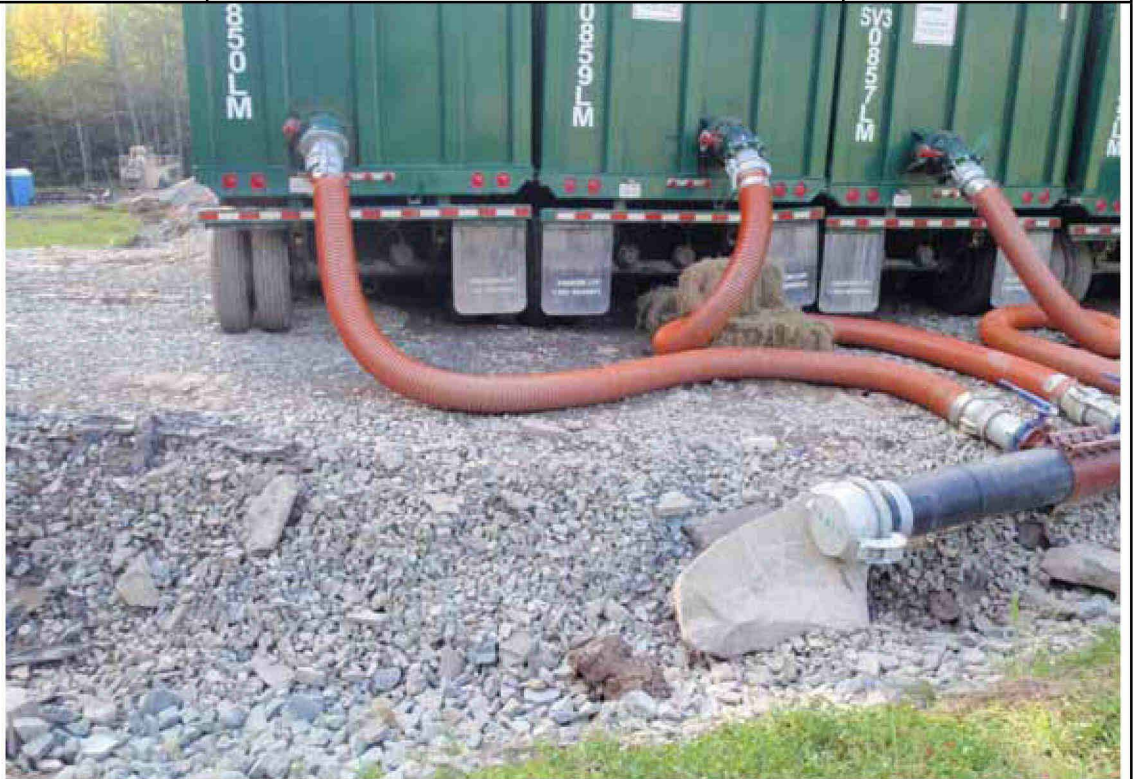
Drainage swale on south side of well pad containing header connecting multiple Baker Tanks.

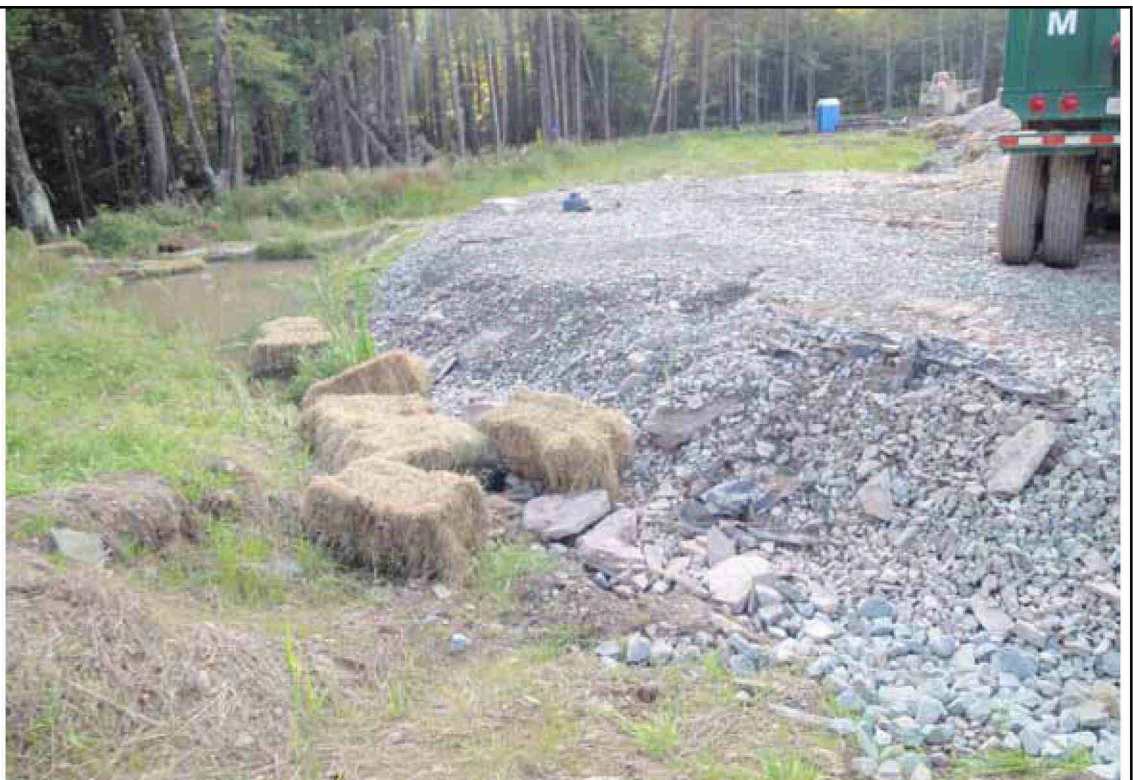
View of drainage swale, catchment basin and wetland along pathway of migration of released frac fluid.

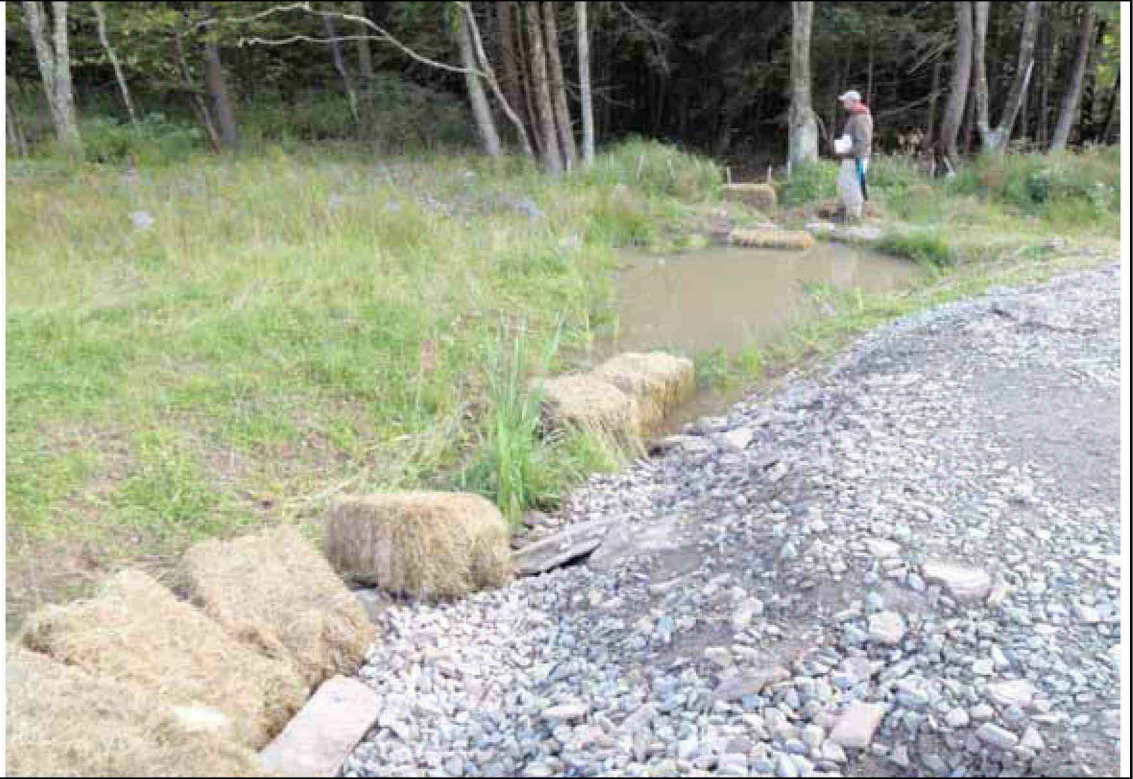
**Photo No.**  
**18**

View of drainage swale, catchment basin and wetland along pathway of migration of released frac fluid.

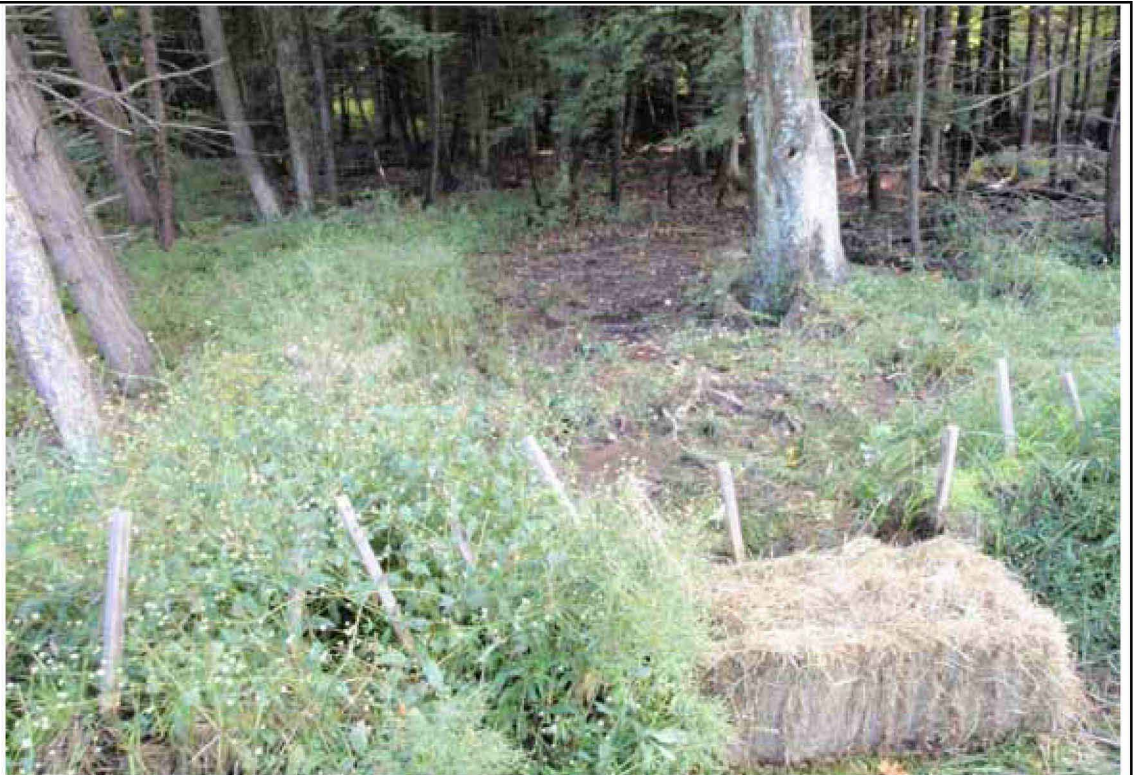
Hay bale E&S control breached by frac fluid release and pathway of migration of frac fluid into wooded wetland area.

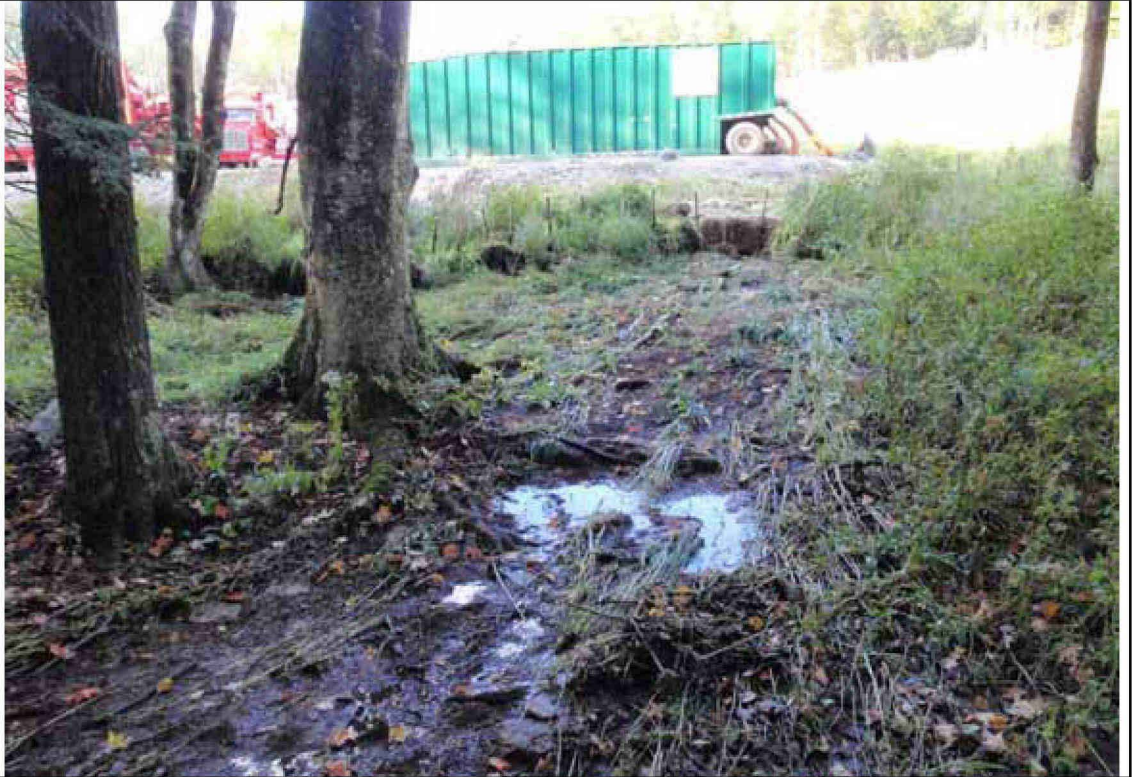
**Photo No.**  
**20**

Looking back to Baker Tanks on Heitsman 4H well pad from the wooded wetland area. Note residual pool of fresh water present after fresh water flushing used to remediate the affected area.

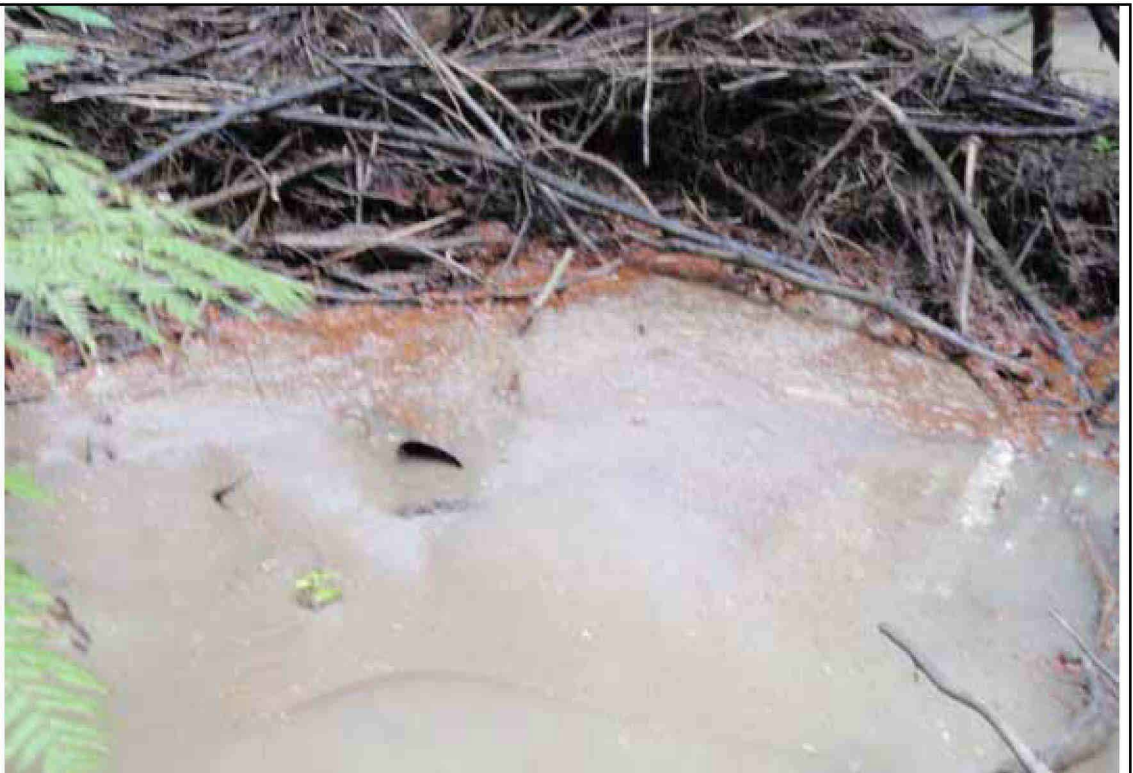
Pooled frac fluid mixed with surface water in Stevens Creek. Stevens Creek was dammed to prevent downstream migration of frac fluid.

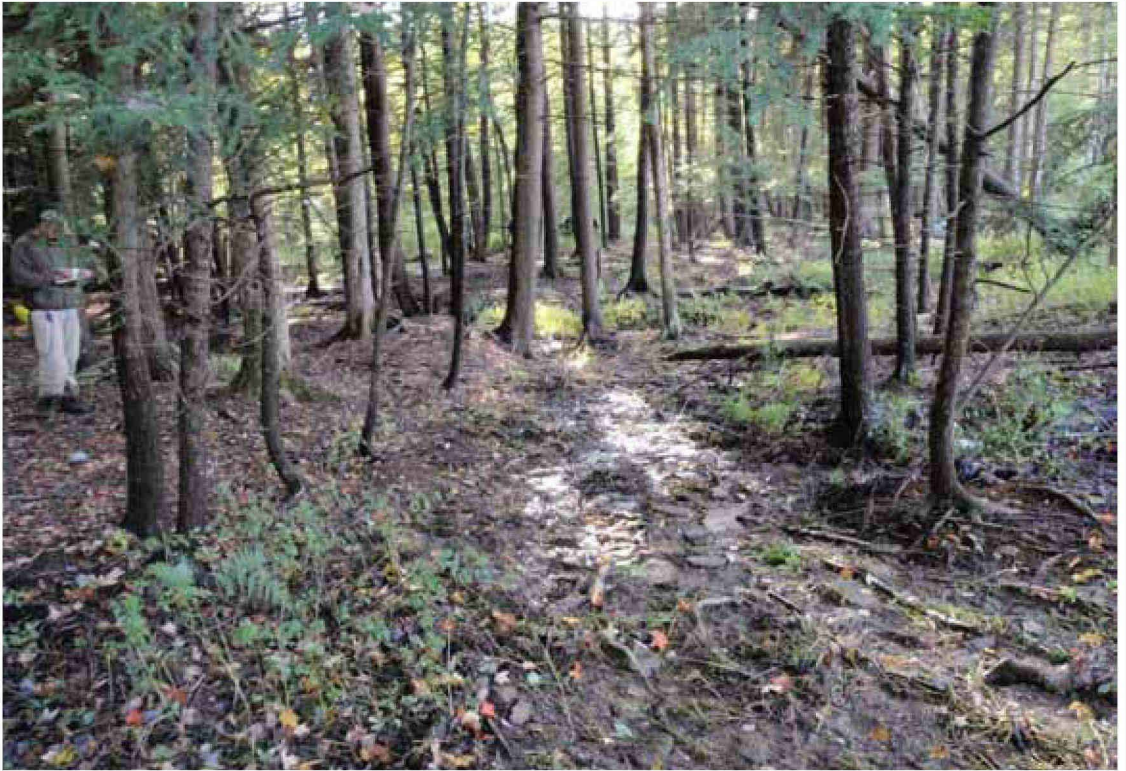
<b>Site Location:</b> Susquehanna County, Pennsylvania	<b>Project No.</b> 39938634.00008
<b>Photo No.</b> 21	<b>Date:</b> 9/17/09

<b>Direction Photo Taken:</b> West			
<b>Description:</b> Pathway of migration of released frac fluid through the wooded wetland area toward Stevens Creek. Note residual pool of fresh water present after fresh water flushing used to remediate the affected area.

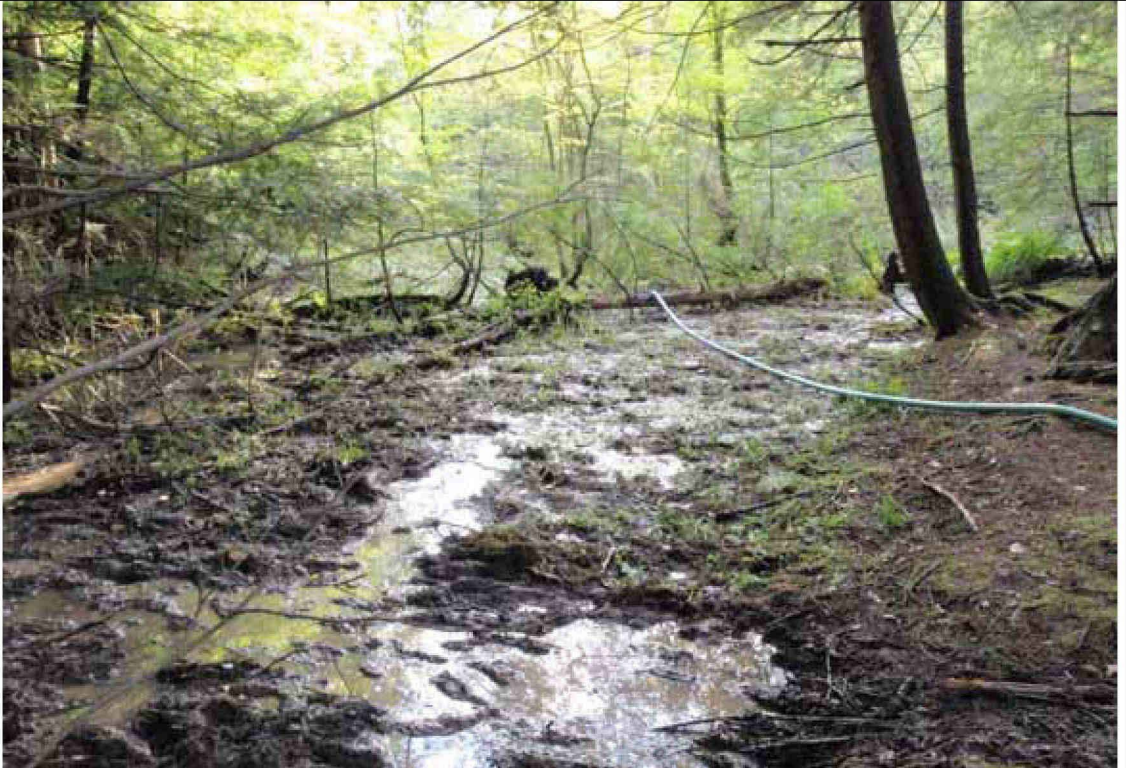
<b>Photo No.</b> 22	<b>Date:</b> 9/17/09

<b>Direction Photo Taken:</b> West		
<b>Description:</b> Pathway of migration of released frac fluid through the wooded wetland area toward Stevens Creek. Note residual pool of fresh water present after fresh water flushing used to remediate the affected area and the hose used to pump water that had been flushed through the pathway of migration back to the well pad for storage and disposal.

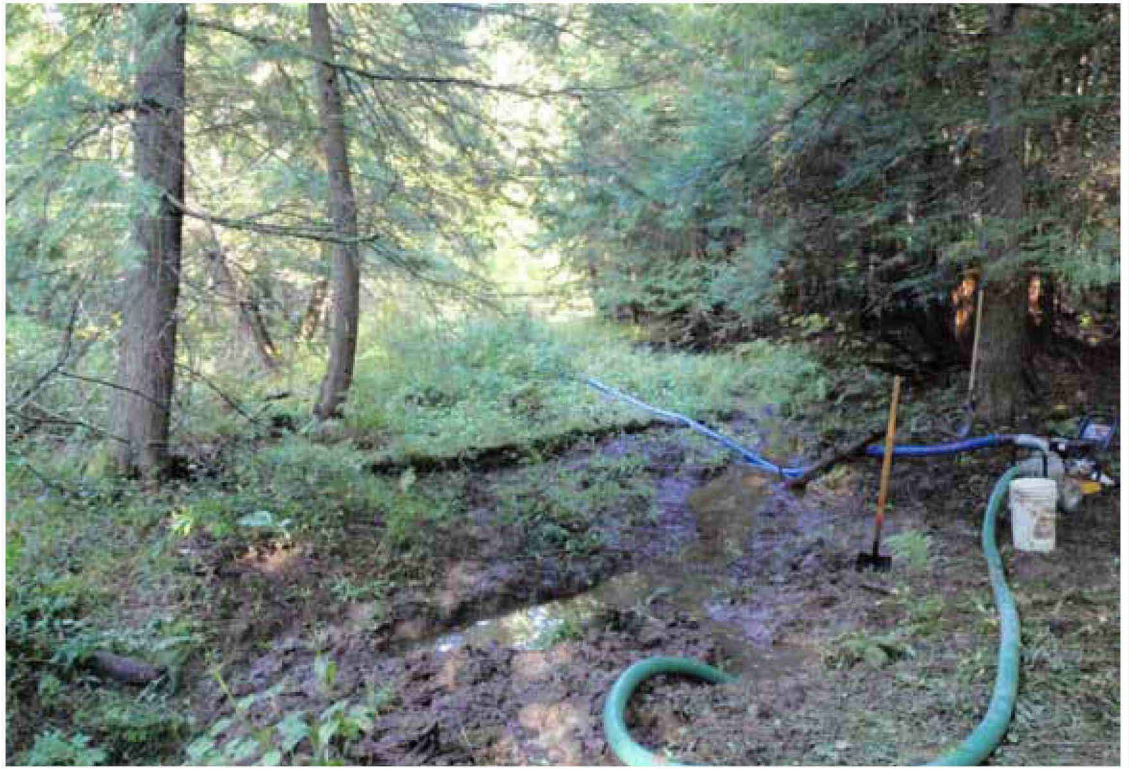
**Photo No.**  
**24**

Containment area near Stevens Creek used to capture fresh water that was flushed through the pathway of migration of the frac fluid and then pumped back to the Heitsman 4H well pad for storage and disposal.

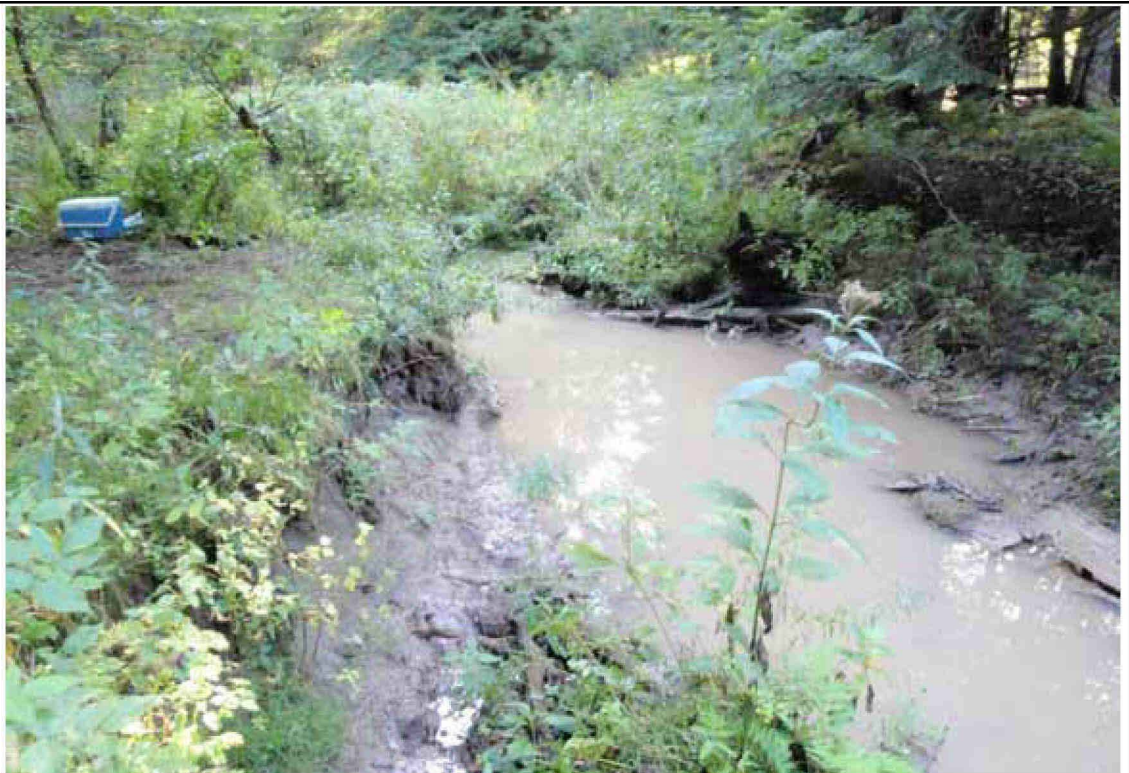
Dammed portion of Stevens Creek affected by the frac fluid release. Note milky white appearance of the water.

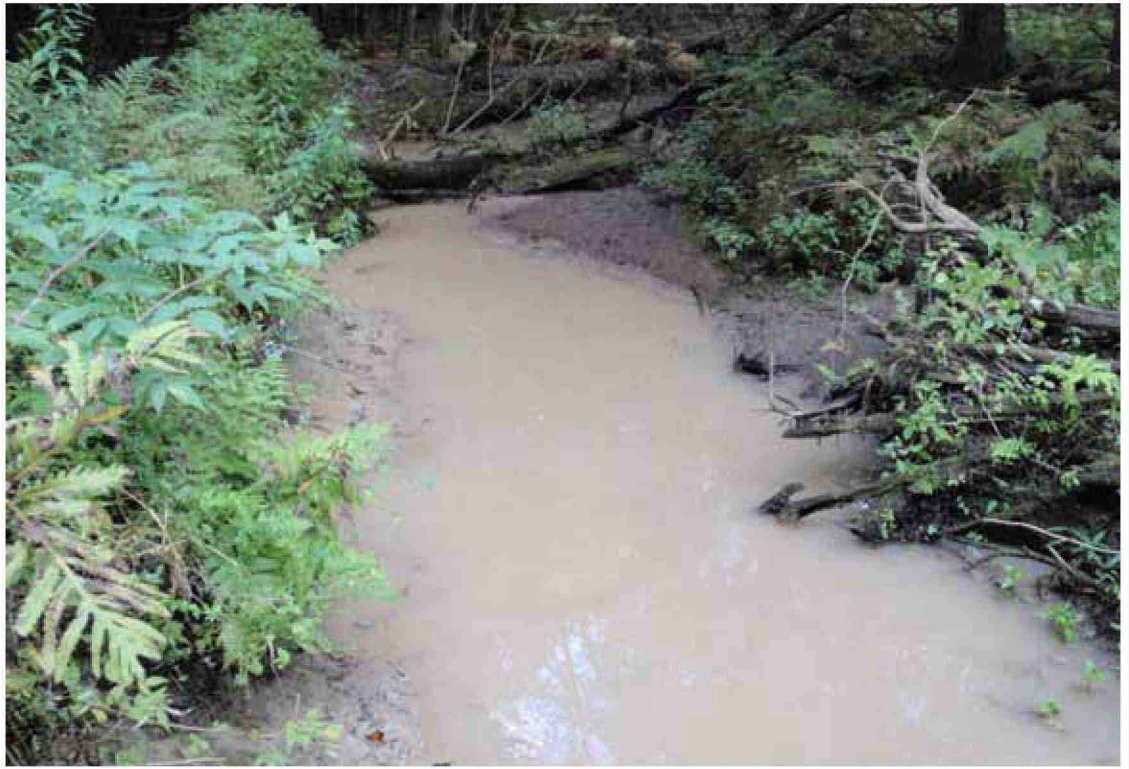
**Photo No.**  
**26**

Dammed portion of Stevens Creek affected by the frac fluid release.

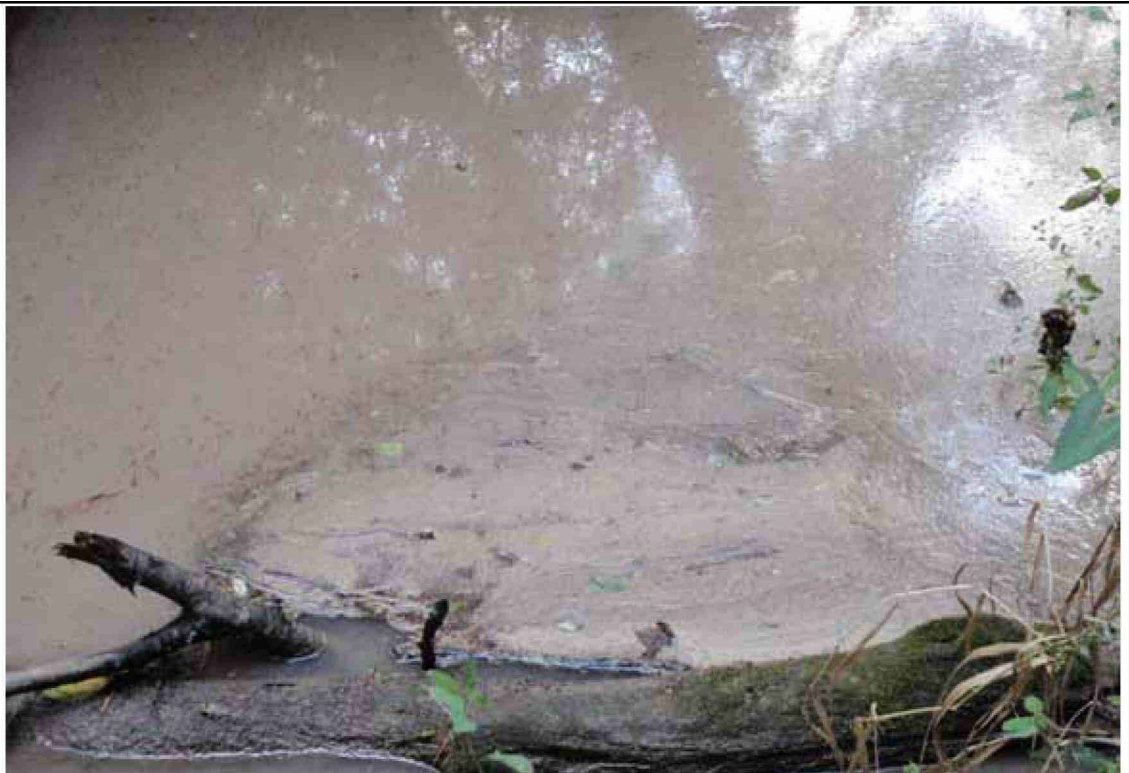
Dammed portion of Stevens Creek affected by the frac fluid release. Note milky white appearance of the water.

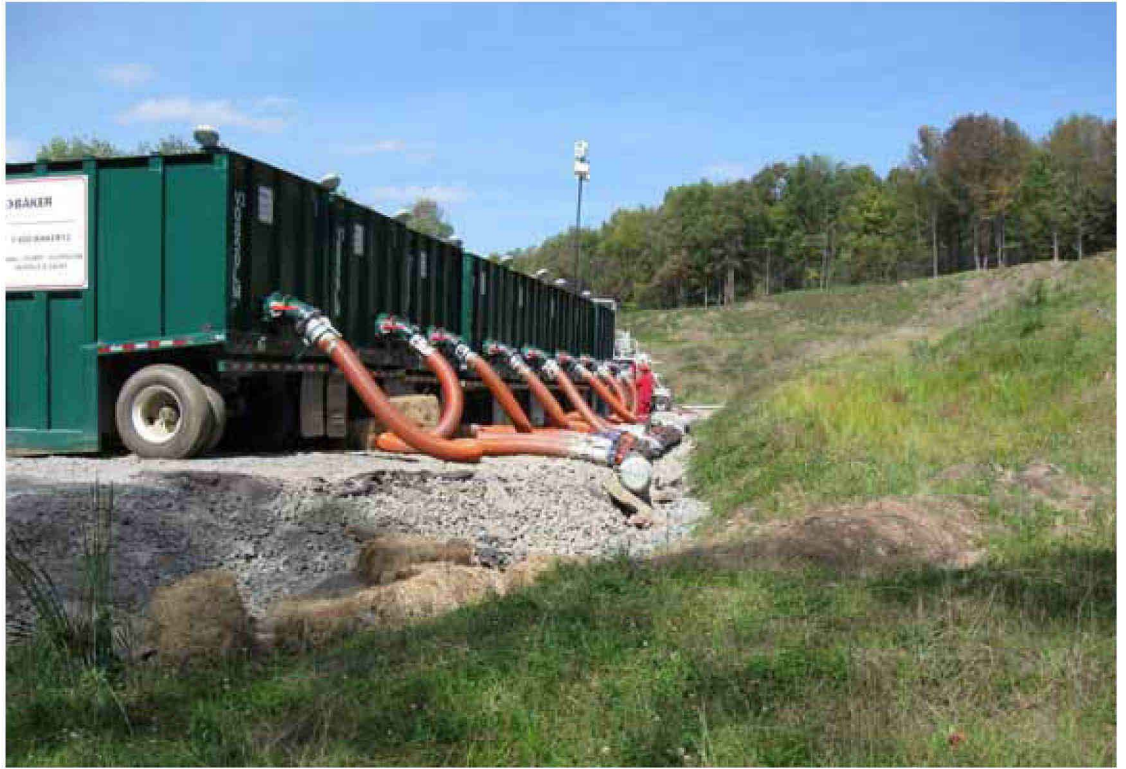
**Photo No.**  
**28**

Drainage swale on south side of well pad containing header connecting multiple Baker Tanks.

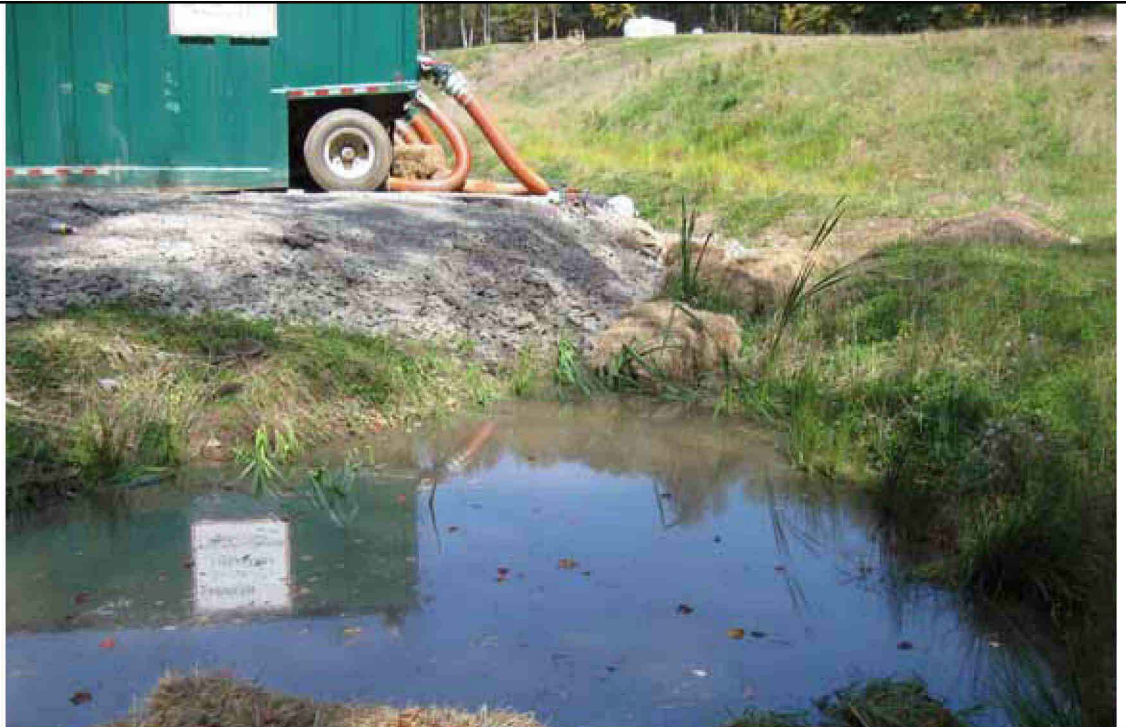
Catchment basin at the southwest corner of the well pad. Note that the basin contains fresh water that has been flushed from the drainage swale.
